**AIRPHOTO PATTERNS OF SOILS
OF THE
WESTERN UNITED STATES**

As Applicable to Airport Engineering

Technical Development Report No. 85

August 1948

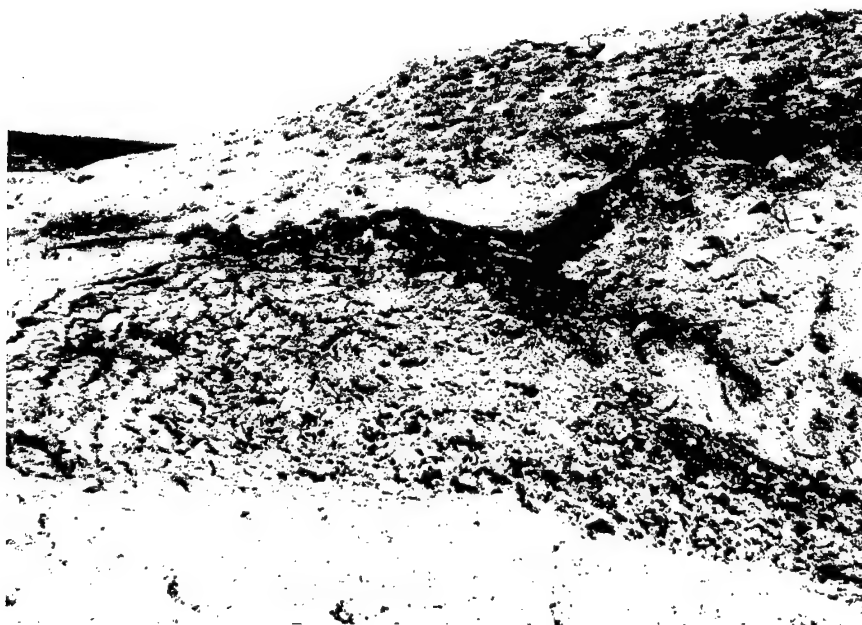
FIGURE 64.—*Scoria in the Making, near Hanna, Wyo. (Mesa Verde formation), from the Burning Lignite Beds. Here the soil has settled where underlying lignite beds have been burned.*

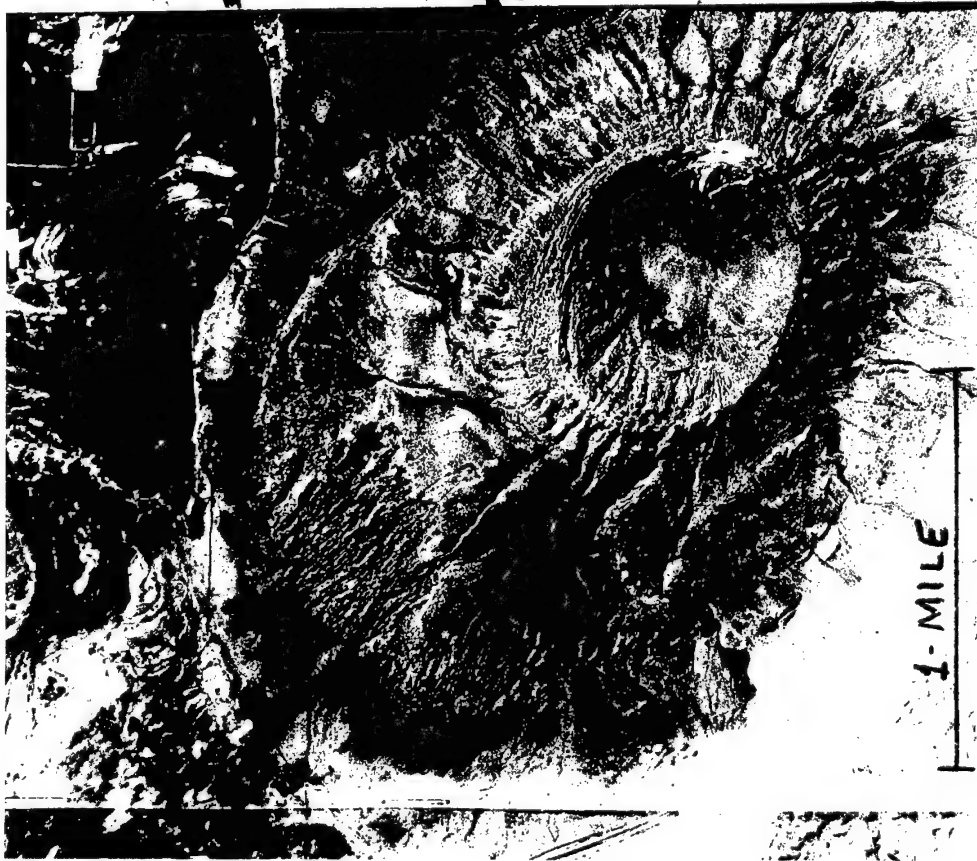
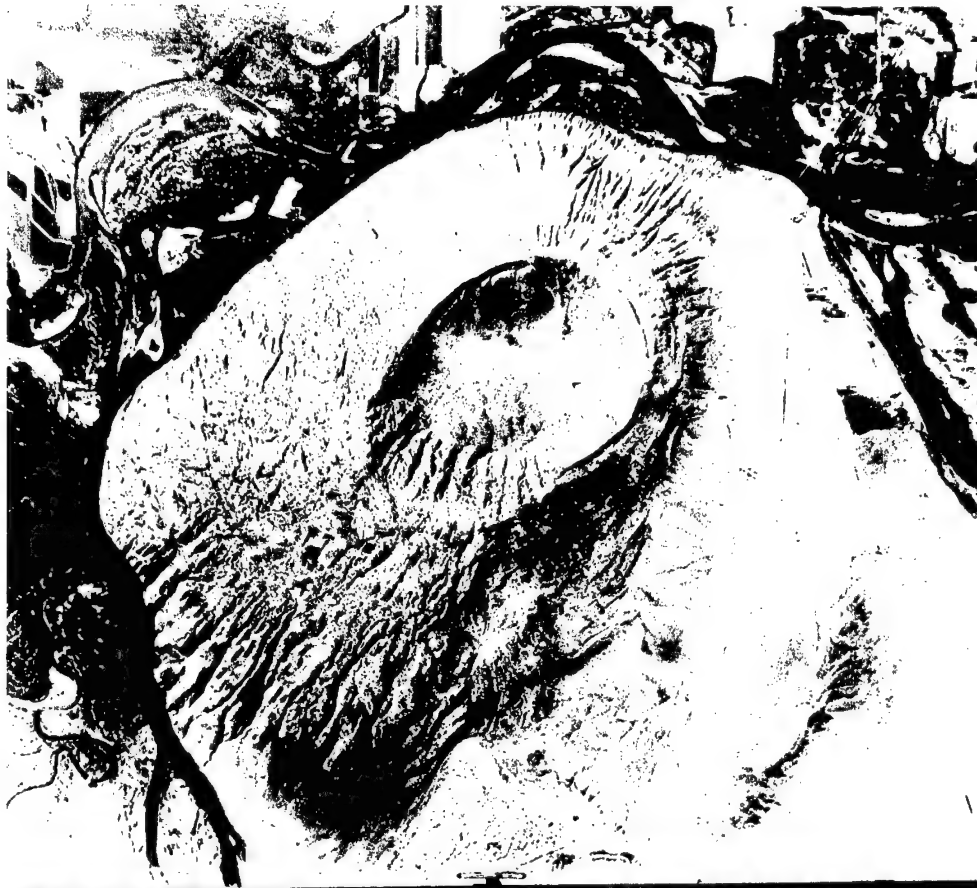
FIGURE 65.—*Volcanic Cinder Cones*. This Jefferson County, Idaho, photo depicts two cinder cones built up of volcanic ash and breccia. Note the radial drainage pattern. This is on the edge

of a basalt plateau consisting of an older flow material. The large size of the craters is indicated by the mile scale.

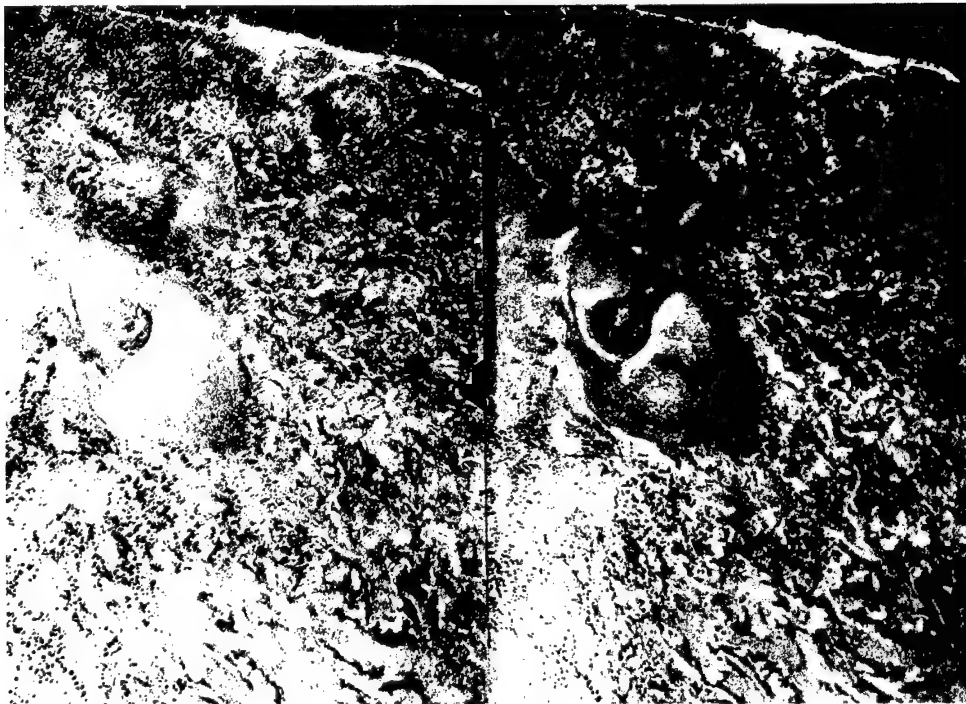
FIGURE 66.—*Stereophoto of Volcanic Cones.* This Shasta County, Calif. area contains three distinct volcanic cinder cones. Note the box-shape of the erosional features of the older lava flow at the base of the large cone.

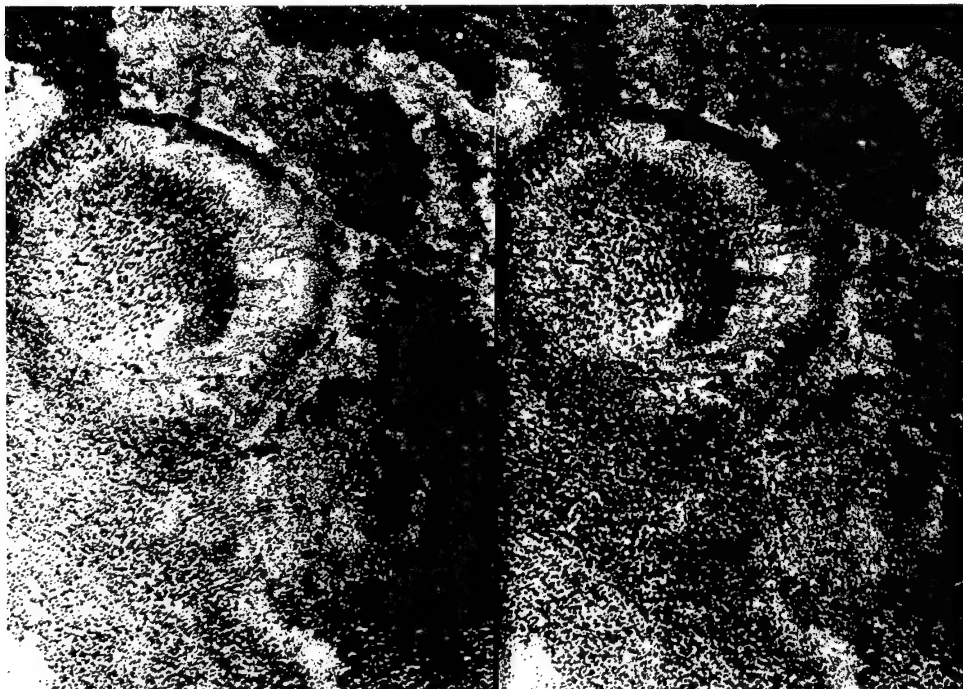
FIGURE 67.—*Stereophoto of a Large Volcanic Cone.* Note the changes which occur in color, vegetation, slope, and in gully characteristics about half-way up the slope of the cone. The dark rocks are remnants of an earlier flow.

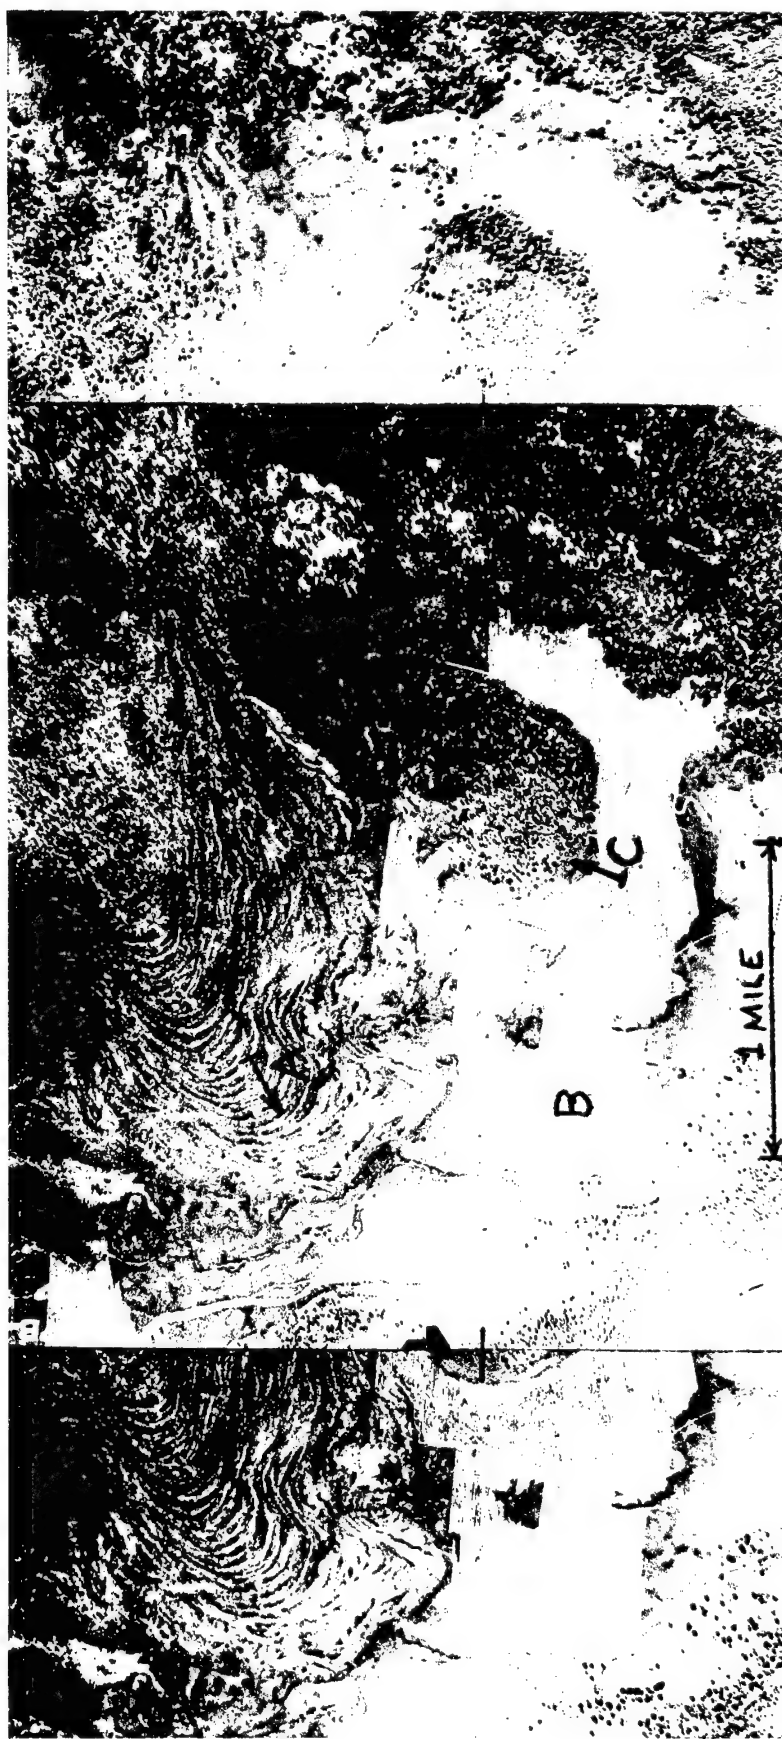
FIGURE 68.—*Stereotriple of a Lava Flow.* This Shasta County, Calif., area contains: *A*, the most recent lava flow; *B*, an older flow covered with pumice and volcanic breccia; *C*, an old crater or volcanic channel. The most recent flow has not weathered sufficiently to produce soil for timber growth.

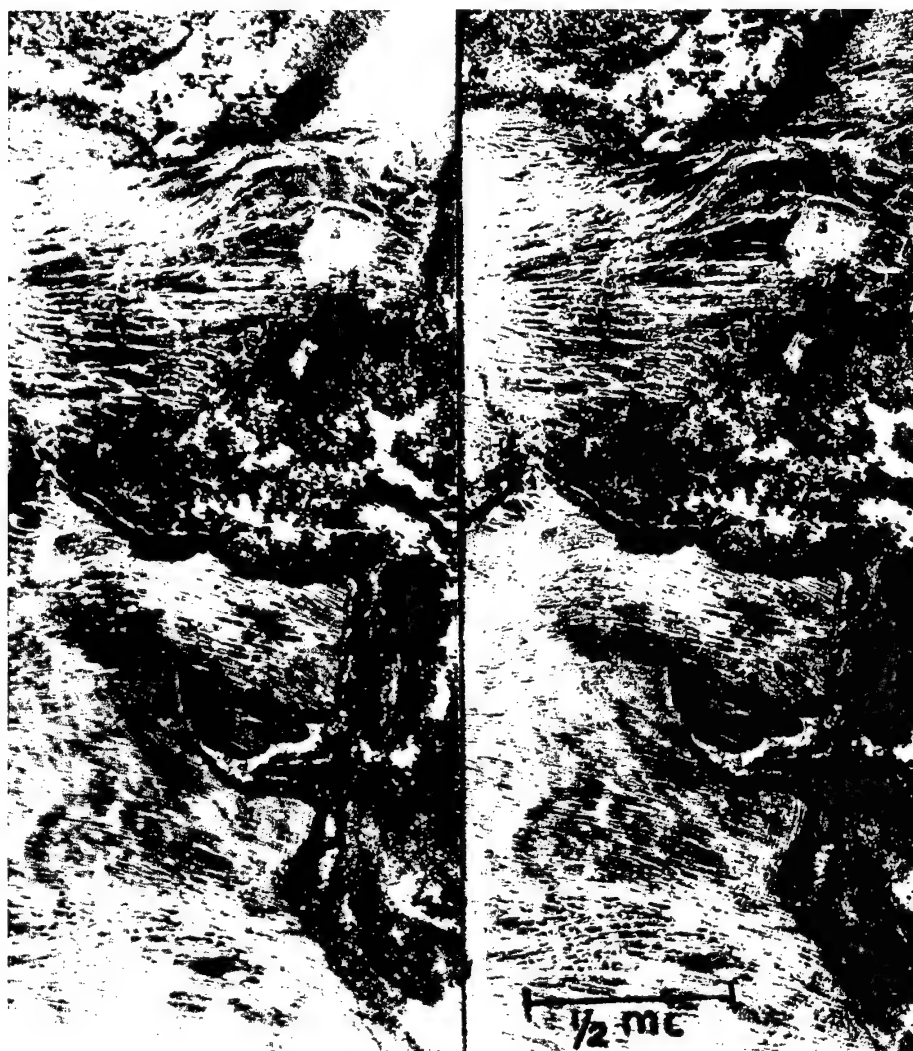
FIGURE 69.—*Stereophoto of a Dissected Basalt Plateau.* This air-photo illustrates one of the many surface features exhibited by basalt flows. Note the streaks or cracks which are contained in the surface. The parallel trend of these may possibly be orientated with the direction of flow of the original deposition. Essentially this area is a high, flat, dissected, barren plateau. Detailed inspection along the vertical faces of the cliff reveals the columnar structure. A change in slope, together with a different pattern of the broad valleys, suggests that the basalt is not very thick and rests on soil of an older period.

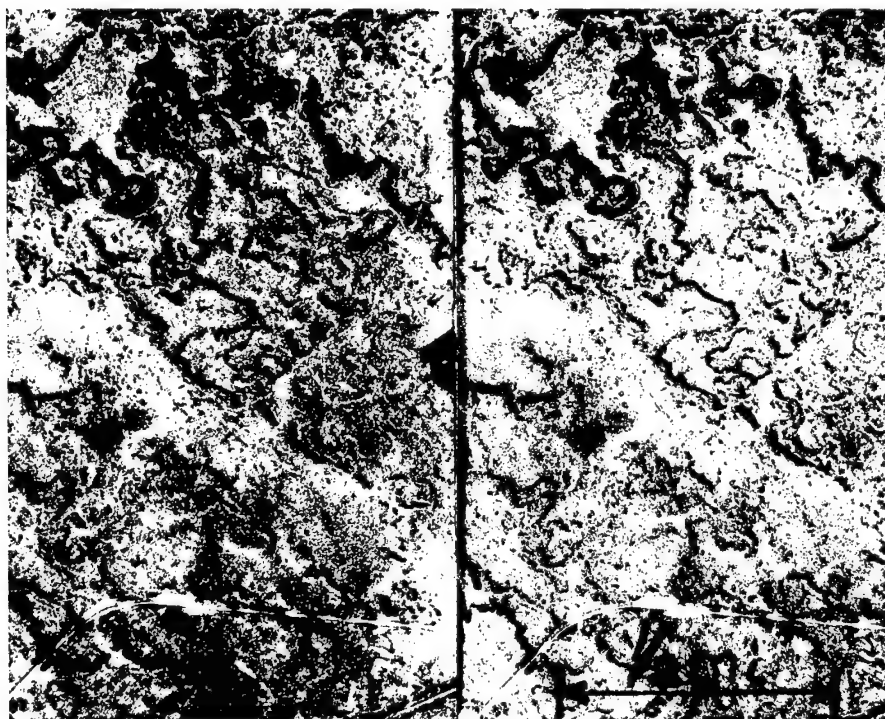
FIGURE 70.—*Highly Dissected Basalt Plateau.* This illustrates one of the erosional features often common to basalt patterns—that of numerous isolated basalt mesas. In this arid region there is very little residual soil development, probably because any soil that develops is removed either by the wind or by flash floods (Jefferson County, Idaho).

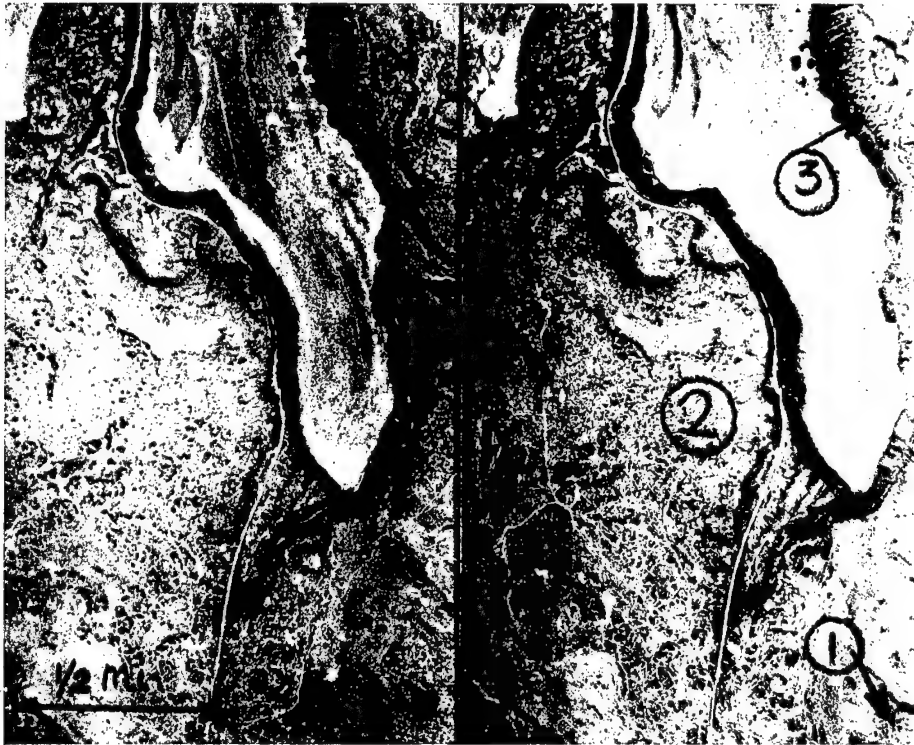
FIGURE 72.—*Stereophoto of a Deep Gorge, or Coulee, in the Columbia River Plateau. There are three basalt flows represented in this photo. The columnar structure of the basalt is exposed along the coulee sides.*

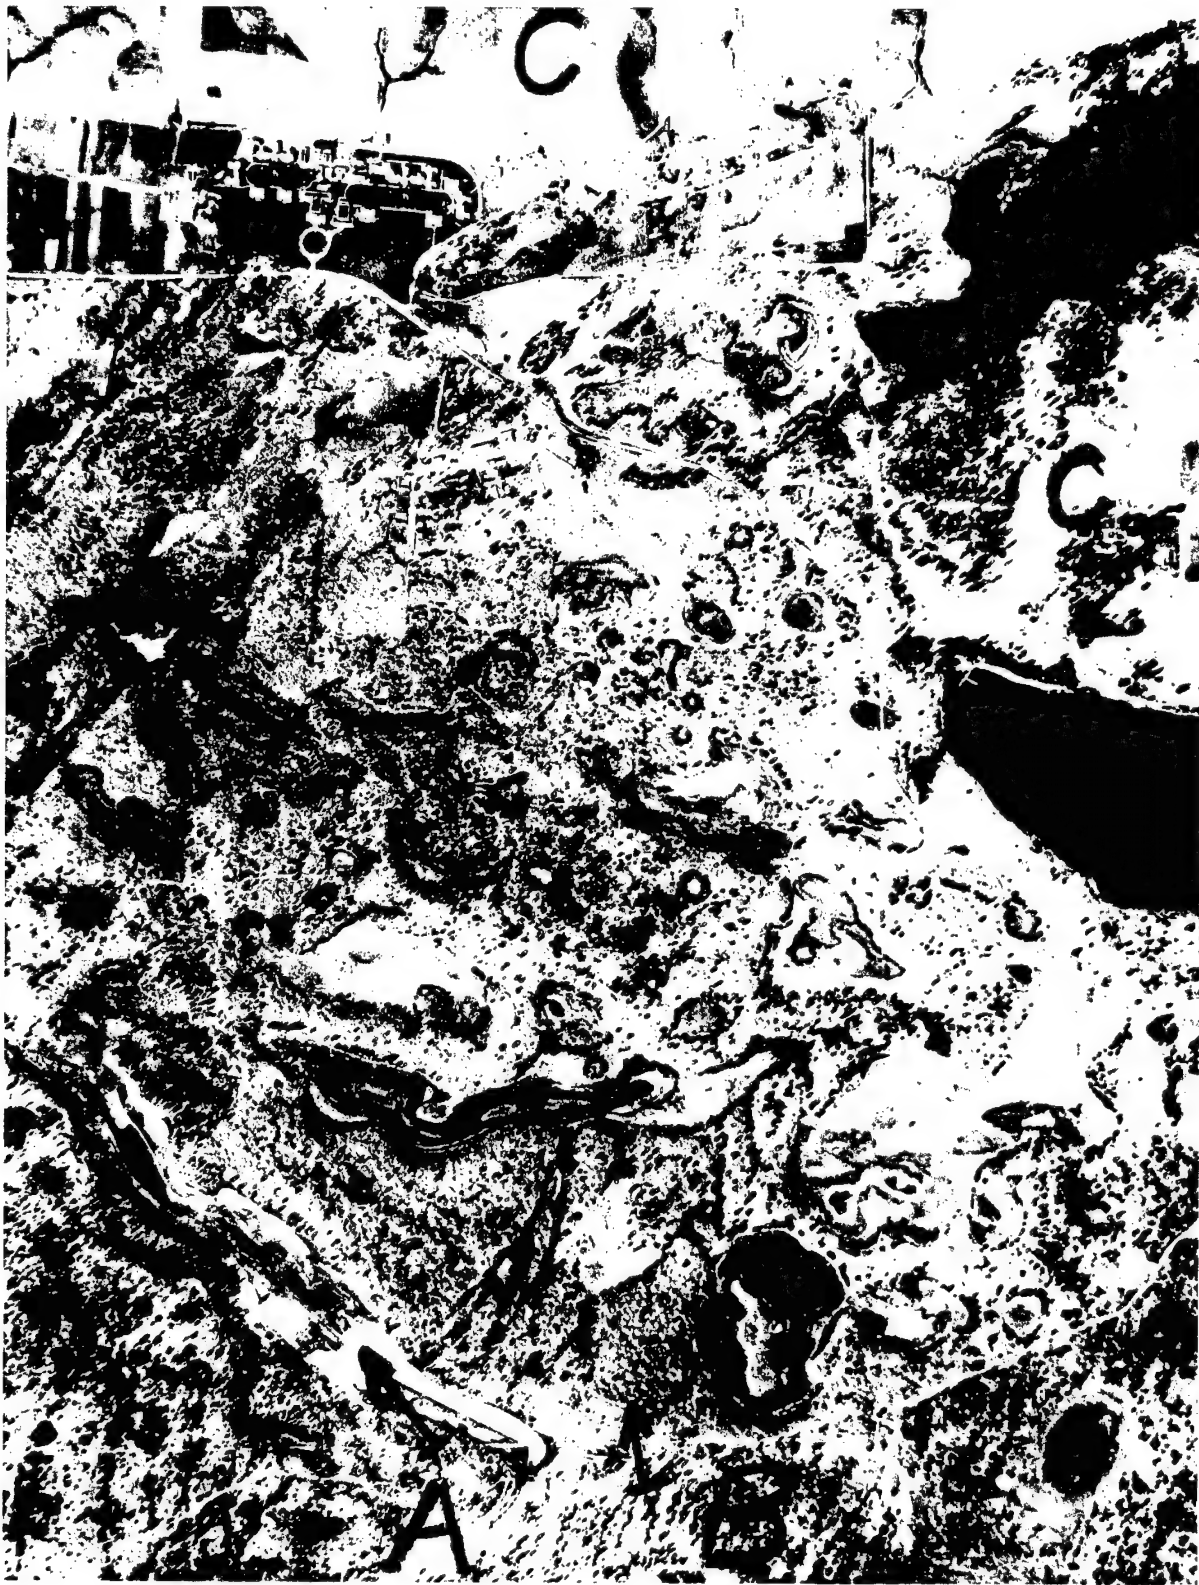
FIGURE 76. --Airphoto of a Basalt Area Termed as "Scab Lands." This photo illustrates the following elements: Nearly flat topography, scant vegetation, large channels, polygons, small mounds of gravel, and orientation of vegetation with the shrinkage cracks in the basalt. The area labeled "A" is an old channel (fig. 77). The arrow at "B" indicates the location of figure 78. Area "C" is a covering of loess.

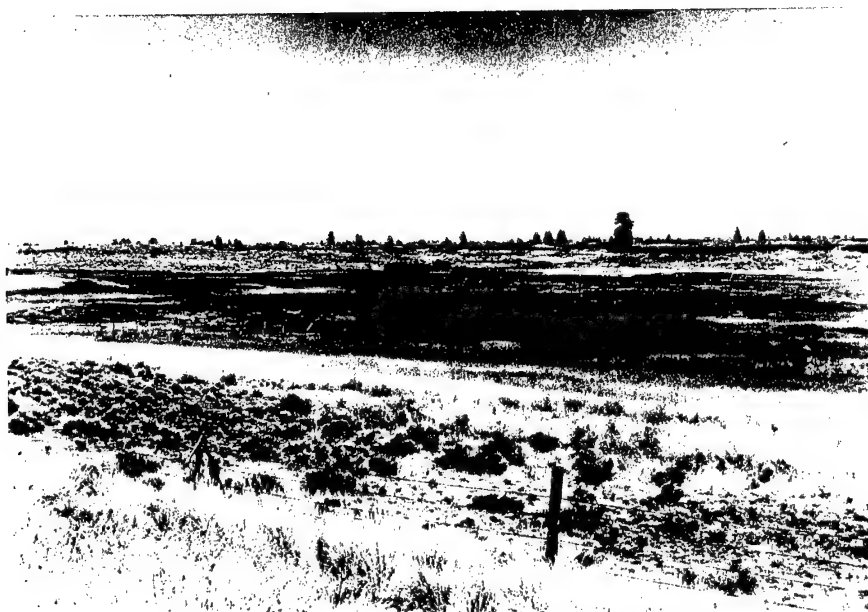
FIGURE 77. *Ground View of a Channel in Basalt (A in fig. 76).*
Note the changes in vegetation; there is grass on the upland flats, sage
brush occurs on the side slopes and marsh vegetation is supported in the
channel.

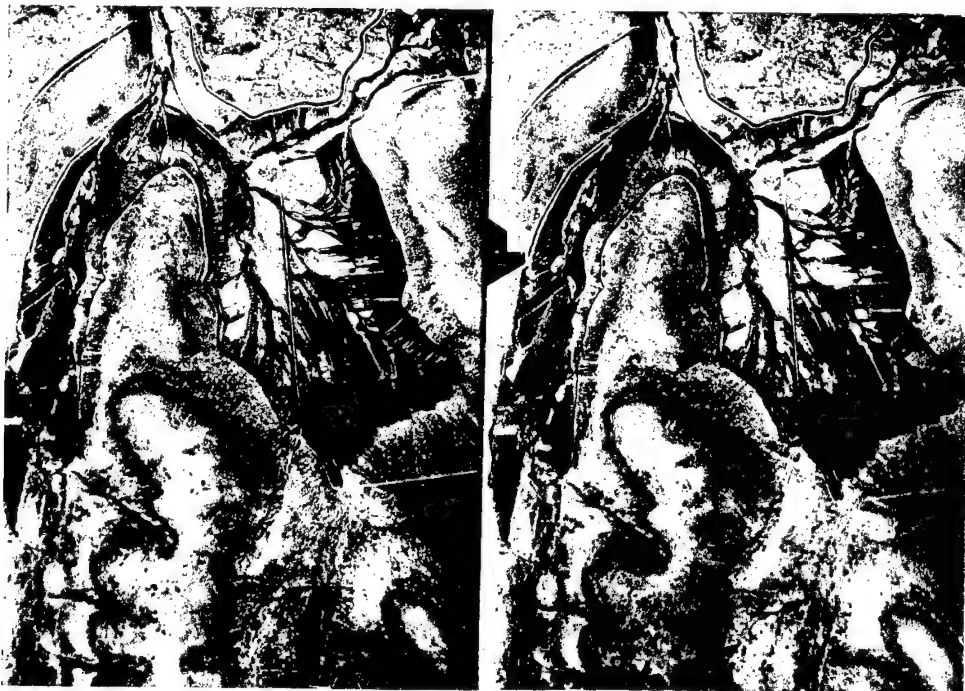
FIGURE 79. *Stereophoto of Thin Layers of Basalt and Thick Layers of Soil Between Basalt Layers (Ellensburg formation). The rounded slopes are produced by the soil mantle and by the soil between the basalt layers. The basalt can be seen as outcropping beds which give a contoured appearance to the hills (Kittitas County, Wash.)*
